Industrial Problem Solving and Failure Investigation of Modern Materials

Dr Simon Romani – Technical Director

Aerospace / Advanced Engineering Show 2016 (NEC) - 2nd November 2016

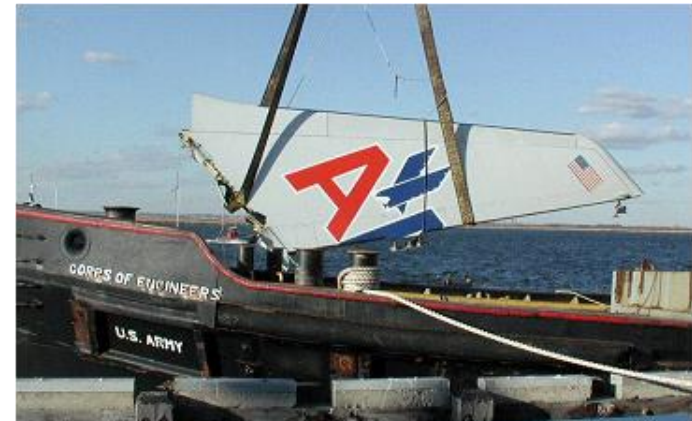
Flight recorder: rudder issues & early loss of stabiliser (found miles from crash site) pointed to possible failure of composite material...

Delamination was noted in build notes, requiring repair..

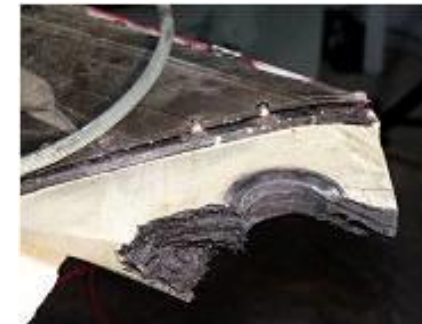
Fractured strut on AA587 stabiliser

SEM & XSEM of fracture surfaces of 3 failed fittings and nearby lamination (100 layer GFRP composite) – No pre-existing faults found (fatigue, etc..)...

Appeared to be over-stress failure...

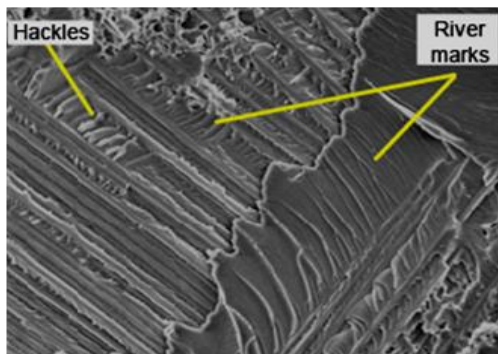
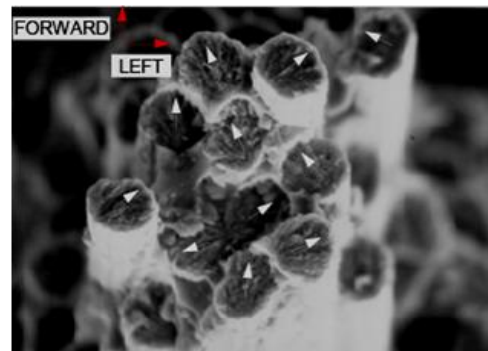
Fracture surfaces
{images from NTSB public report}...

- Design Flaw?
- Large rudder excursions of +/- 11° (full-lock positions), many times over just a few seconds.
- NASA Simulation showed this could generate stabiliser loads above 200,000 lbs... Exceeding maximum loading for fracture.
- Eventual root-cause: Error in pilot training highlighted... (unrealistic flight scenario, leading to gross over-reaction if ever used in normal flight situations...)

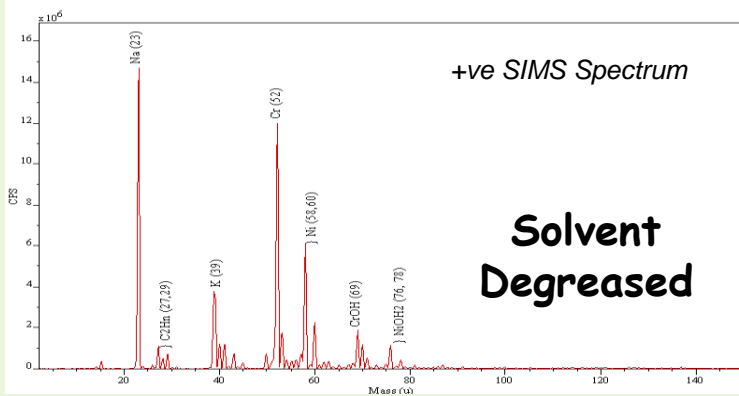
- Removed hydrocarbon
 - Underlying Ni and Cr exposed.
 - Some Na and K visible.
- ➔ Clean surface

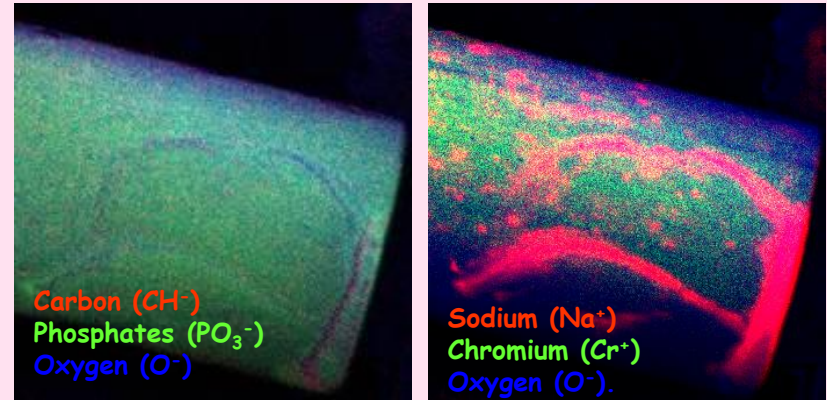
Aqueous Degreased (2.5mm FoV)

- Most of hydrocarbon removed
- Underlying Ni and Cr exposed
- High levels of Na, Si, K, Ca, Cl, Phosphates, Silicates and Nitrates from the aqueous degreasing solution.

- The solvent process is a better cleaning process.
- Aqueous process leaves more remnants behind, causing functional problems.

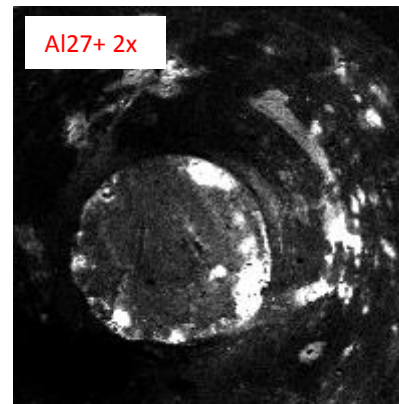
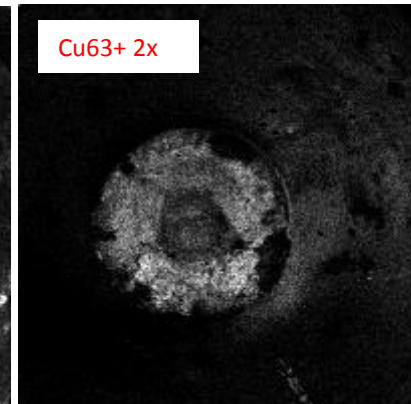
- Build up of thin layers of alumina at edge.
- Quantity of residual alumina changed electrode resistance so power per unit area and force varied over time.
- Weld power set too low to stop alumina build up.

SIMS Images of Bad Electrode....

Higher Power and Force Solved Problem.

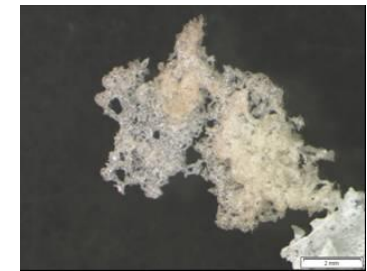
Packing material – Polyurethane prepolymer - Not fully cured
- Not a source of inorganic debris

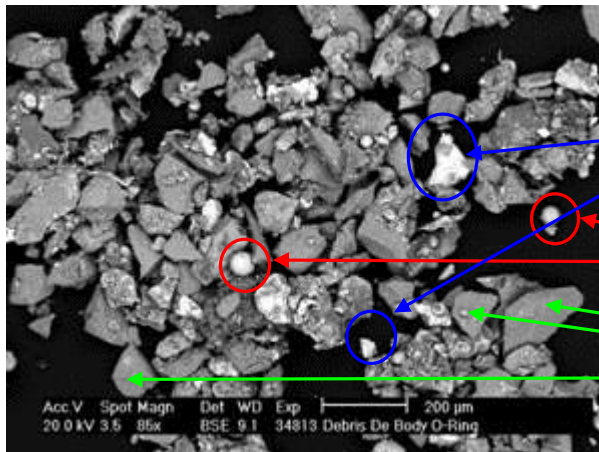
Irregular titanium rich probably metallic flakes

Iron Oxide Coated Spheroidal Particles – Weld Splatter

Common Aluminosilicate Glass Particles / Fragments

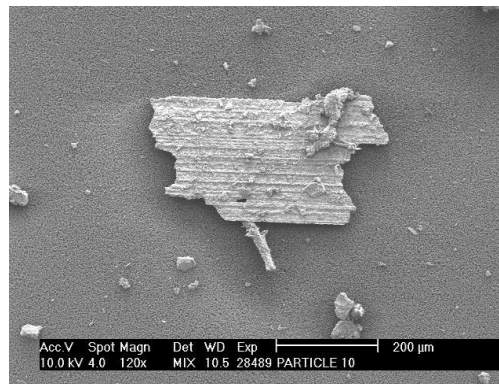
Metal oxide particle with characteristic machine marks

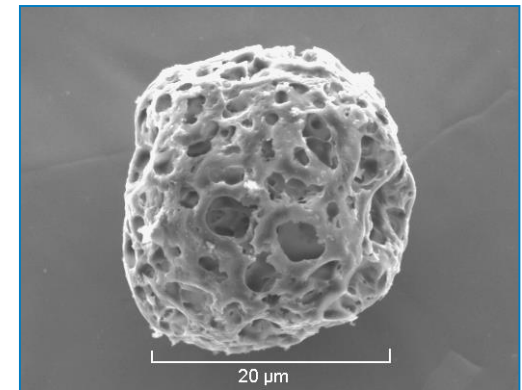
Charred pollen grain found to block a filter.
