Investigation of Stainless Steel Strip Laser Welding Problems – Solved Using Auger Electron Spectroscopy Depth Profiling

Production Process Problem

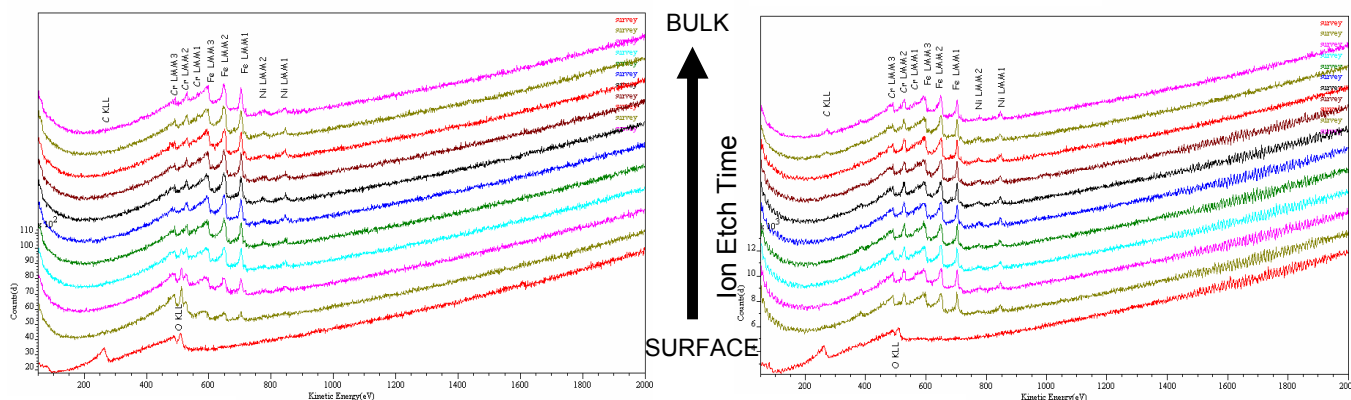
Fig.1. Auger Electron Spectroscopy depth profile montage spectra of 2 stainless steel samples. The yellow discoloured area of the strip proved very difficult to laser weld compared to normal material.

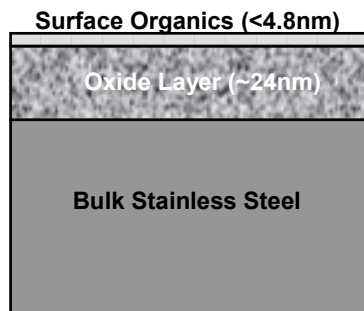
Fig.2. Schematic of the surface structure revealed by sputter depth profiling in Fig.3.. The surface oxide is surprisingly thick for a stainless steel, particularly since the material had just been furnace reduced.

Auger electron spectroscopy and depth profiling has shown that the subtle yellow discolouration on certain parts of the reel strip was due to excessive surface oxidation of the stainless steel. This oxide layer made weak welds as it was interfering with the laser welding process.

The problem at the downstream laser welding process could be solved by quick removal of the finished spool or more reliably by preventative scrapping the extreme ends of the spool following the furnace treatment.

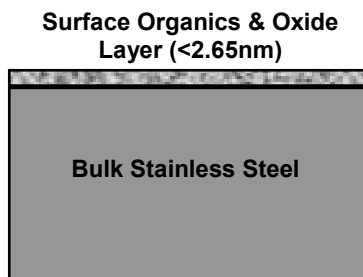
Fig.4. Schematic of the surface structure revealed by sputter depth profiling in Fig.5. The surface oxide on the stainless steel is much thinner than in the yellow discoloured areas.

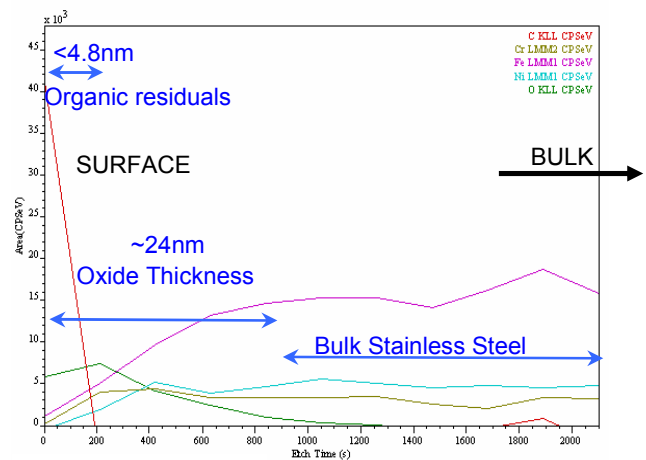
Careful optical inspection of the strip showed there was a consistent spacing between discolourations and the damage was always close to one end of the spool. As the spools of wire were continuously fed through a tube furnace it was possible to match this to gas burn-off points at either end of the hot zone. A low level of ingress of air at these points caused the oxidation and this was made significantly worse as the production tool stopped periodically awaiting a spool change.

Fig.3. Quantified Auger depth profile of yellow discoloured area with poor weld-ability- Etch rate = 1.36nm/min

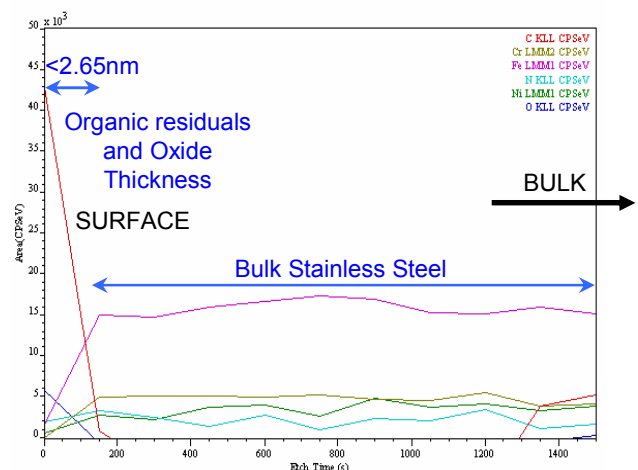
Fig.5. Quantified Auger Depth profile of Normal Easy-to-Weld Material– Etch rate = 1.06nm/min
