Effectiveness of an Aqueous Degreasing Process Evaluated and Improved by XPS

Production Process Problem

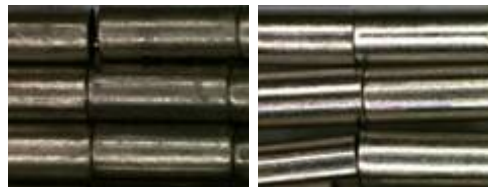
The component appears optically a different colour if it is not cleaned, but if partially clean can appear similar to a good clean component.

Fig.1. Optical images of as-cut tubes (left) and after aqueous degreasing (right).

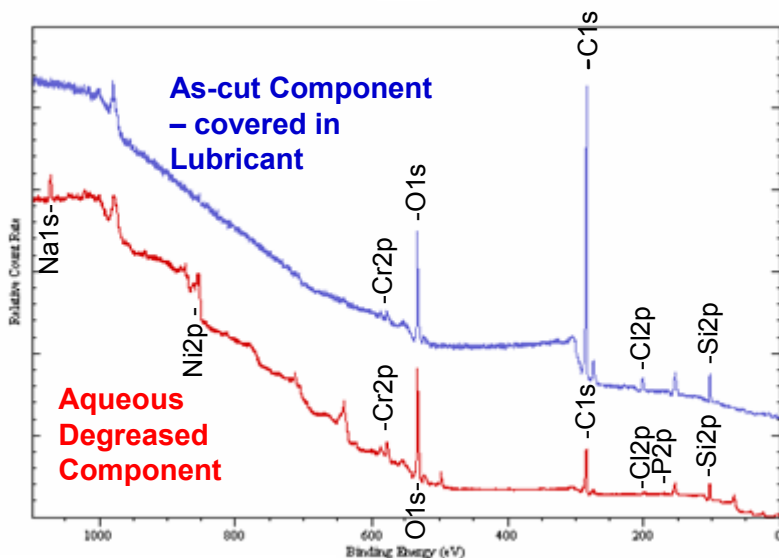
Fig .2. Comparison of the XPS survey spectra from the surfaces from the as-cut tubes and similar components after aqueous degreasing.

Aqueous degreasing of the cut tubes had removed most of the surface carbon (hydrocarbon) and surface chlorine. This cleaning process had revealed the underlying nickel and chromium.

The fact that the surface chromium could be seen in the dirty sample suggests the lubricant was less than a few nm thick. Since there was only subtle evidence of nickel, this suggested the lubricant was a fairly continuous overlayer rather than localised blobs.

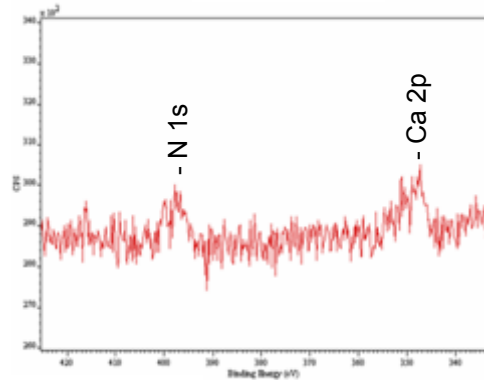
Sodium residue was evident on the surface of the degreased components. There were also trace levels of calcium, phosphorous (present as a phosphate) and nitrogen (present as a cyano or nitride species).

These results indicated the rinsing off of degreasing solution was incomplete and the presence of calcium indicated a poor purity of water was used to either make up the degreaser solution or rinse off the aqueous degreaser.

Fig.3. Zoomed survey scan from the aqueous degreased tubes showing the presence of trace calcium and nitrogen as a cyano or nitride species.

The extent of the cleaning residuals was reduced by more extensive post-cleaning rinsing processes. As XPS was far more sensitive than optical examination, it was used to tune the cleaning and rinsing processes minimising harmful residuals and improve welding process yields and eliminating downstream functional issues.

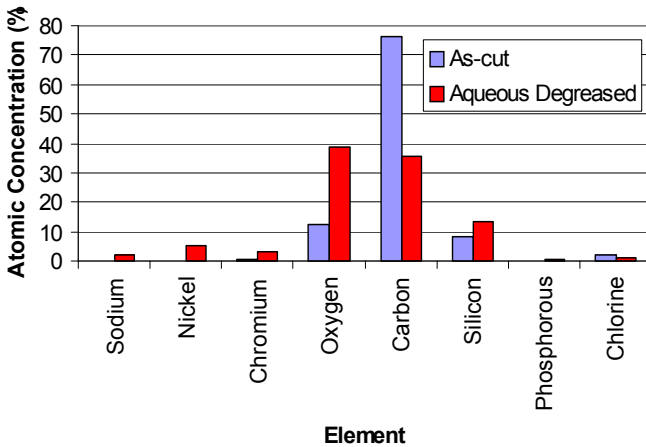
Quantification - Atomic Concentrations (%)	
	As-cut	Aqueous Degreased
Sodium	0.01	2.24
Nickel	0.13	5.25
Chromium	0.49	3.00
Oxygen	12.48	38.96
Carbon	76.27	35.47
Silicon	8.43	13.47
Phosphorous	0.04	0.64
Chlorine	2.16	0.96

Fig.4. Bar chart and corresponding table quantified elemental comparison of the main elements present on the as-cut and aqueous degreased tube surfaces.

The aqueous degreasing process had removed the vast majority of the lubricant exposing the underlying metal, but had left sodium compounds behind on the production component surface which could cause functional problems.
