Consultant Metallurgical Investigation of a Failed Wood Drill Bit

Report Number: T1234

23 April 2020

LPD Lab Services Limited

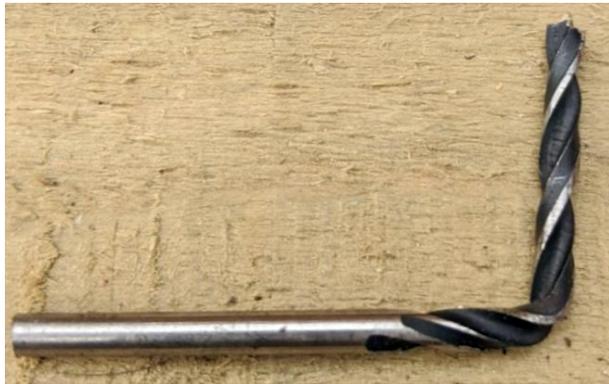
The failed drill bit is shown in Figure 1. It had bent nearly 90° at a location three quarters up the body. For a drill bit to have bent like this indicated that it did not possess sufficient yield strength to serve its intended function.

Figure 1. The failed drill bit.

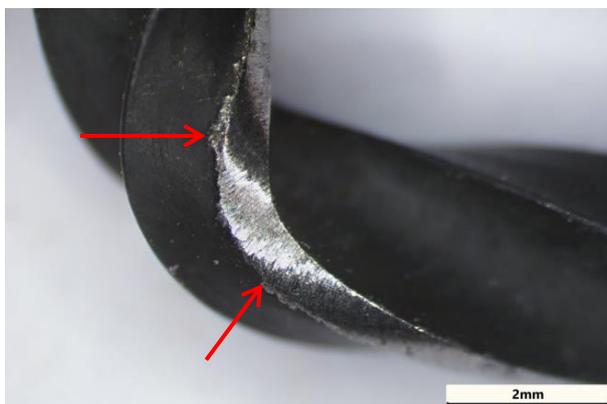
Low magnification examination was performed on the failed drill. There was evidence of wear along the margin and in a number of places a burr had formed behind the margin and it was overhanging onto the land, as shown in Figure 2. This could have been an indication that the material had insufficient wear resistance to perform its designed task, or it could have suffered careless grinding practice during manufacture depending on the extent of use before failure.

Figure 2. Burr forming behind the margin and overhanging onto the land.

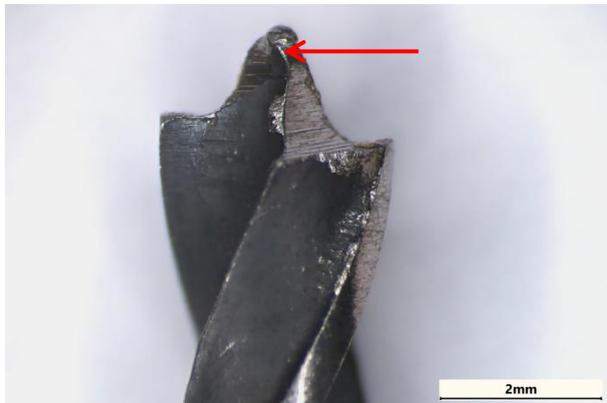
The tip of the centre point was twisted and this indicated that the material probably had insufficient strength to perform its intended duty. This is shown in Figure 3 and at higher magnification in Figure 4.

Figure 3. Deformed centre point.

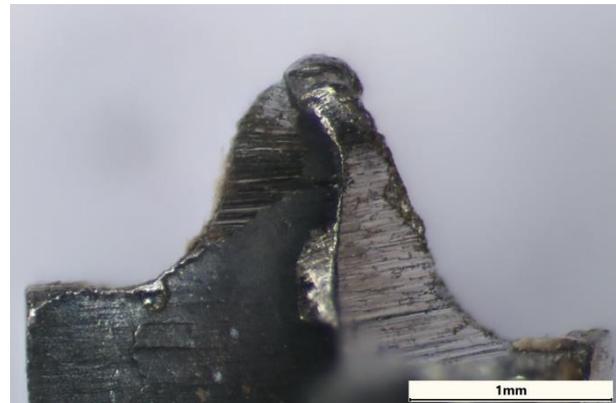
Figure 4. Higher magnification of the twisted centre point.

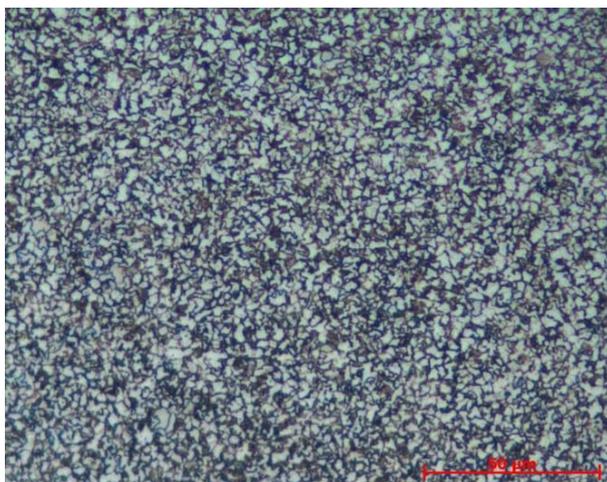
Examination of the metallographically prepared sections from both ends of the drill bit indicated the material to have very fine grains. The microstructure was in the tempered condition and comprised a mixture of ferrite, martensite, pearlite and perhaps bainite. The microstructure was the same at the tip as it was at the shank. A mixed microstructure is not suitable for any tool and it indicated that the heat treatment performed on the drill bit was incorrect. It is crucial that tool materials are heat treated to obtain a fine tempered martensitic microstructure.

Figure 5. Microstructure of the tip, consisting of ferrite, martensite, pearlite and perhaps bainite.

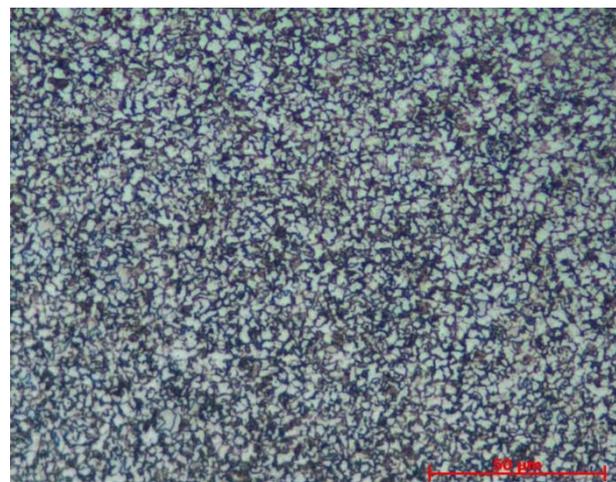
Figure 6. Microstructure of the shank, also consisting of ferrite, martensite, pearlite and perhaps bainite.

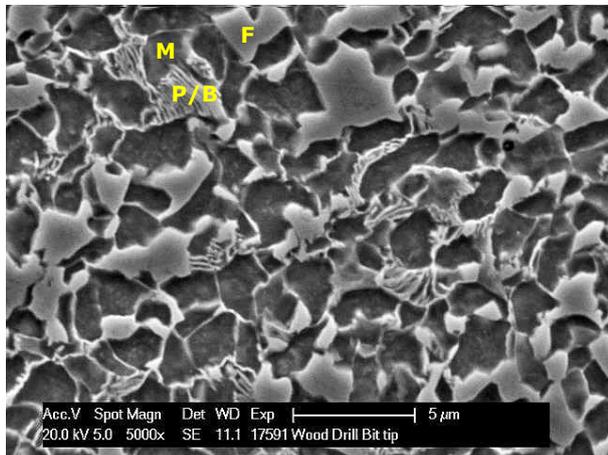
In order to resolve the very fine microstructure of the drill bit it was examined at higher magnification in the SEM. Figure 7 shows the microstructure at the tip and Figure 8 shows the microstructure at the shank. At this high magnification there appeared to be subtle differences with the shank seemingly having larger martensitic grains and a more bainitic than pearlitic phase.

Figure 7. SE image showing the microstructure at the tip, consisting of ferrite (F), martensite (M), pearlite (P) and/or bainite (B).

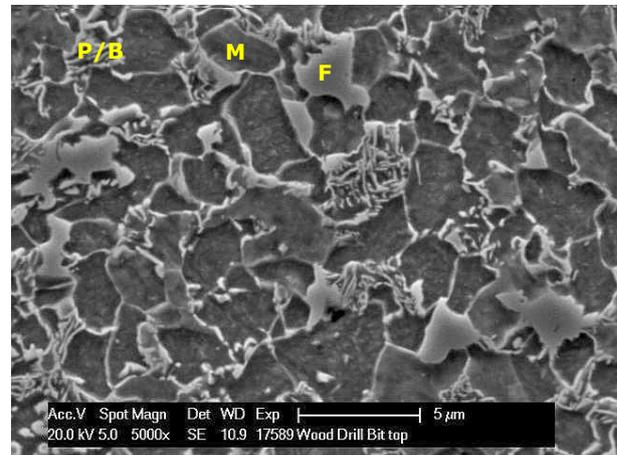
Figure 8. SE image showing the microstructure at the shank, consisting of ferrite (F), martensite (M), pearlite (P) and/or bainite (B).

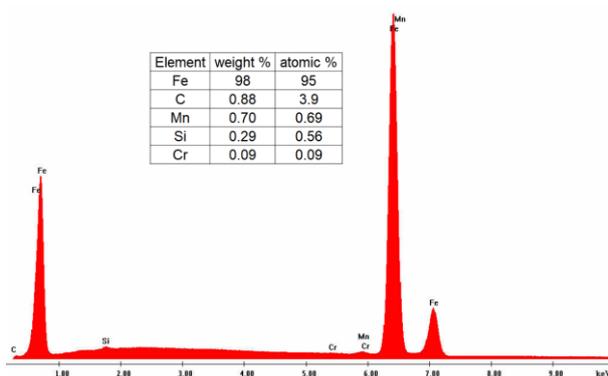
The EDX spectrum and semi quantitative composition of the drill bit material is shown in Figure 9. The composition indicated the material to be medium carbon steel. Note that the carbon result produced by EDX is typically higher than the actual value. A separate carbon analysis is required to get a more reliable figure, but this was deemed unnecessary based on the wider findings in this report.

Figure 9. EDX spectrum and composition of the drill bit material.
