Metal Component Thermal Blackening Process Failure Solved by SIMS

Production Process Problem

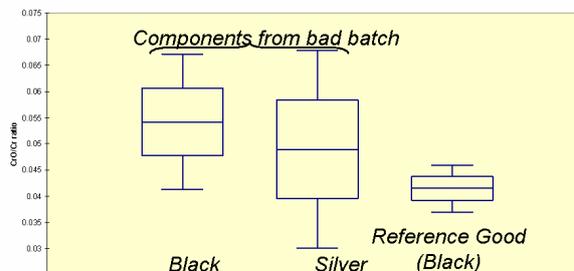
Fig.2 Box plot showing Cr/CrOH for reference 'good' black components plus silver and black components from the suspect 'bad' batch. The ratios come from SIMS peak heights in the spectra and relate to oxide thickness. A box plot shows the mean value, distribution and range.

The fact that the CrO/Cr ratios were different for 'good' and 'bad' black components, proved that cross-contamination of the 'bad' black components had occurred. Processing with the incorrect silver components altered oxide growth rate of the rest of the components in the batch.

On the basis of the information from SIMS it was advised that the suspect component batch could not be used for production purposes – even with the silver components removed, because of the risk.

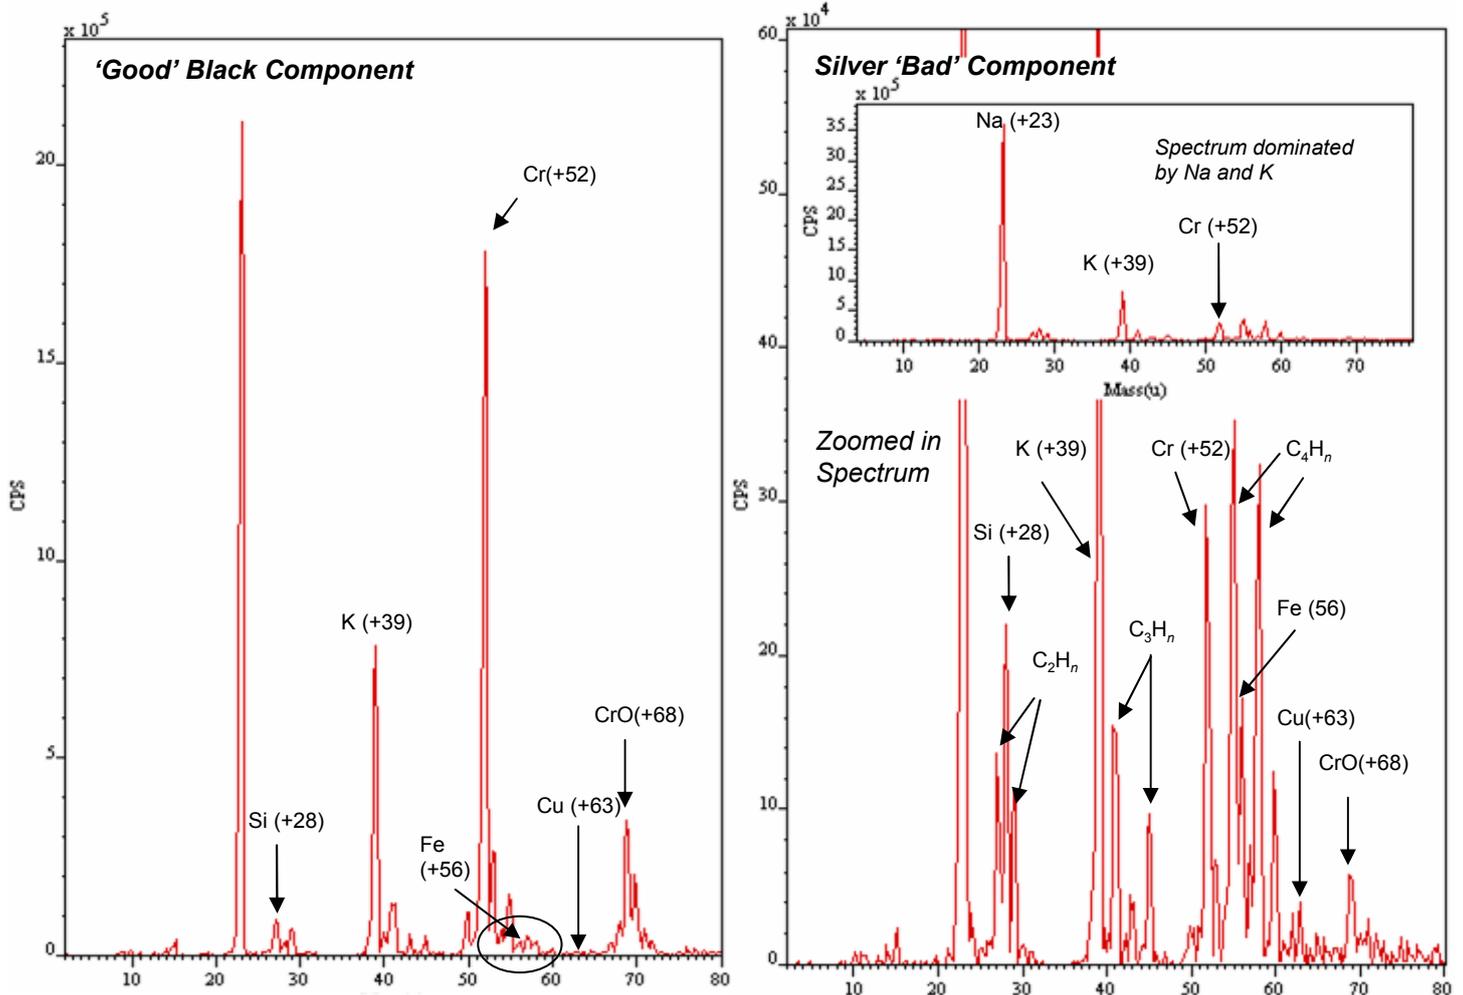
The SIMS analyses in fig.3. were able to show large differences between the normal 'good' black and the 'bad' silver components, which included silicon and hydrocarbon based contaminants.

The silver components were made from a different alloy than normal production. This could be seen in a range of spectral features and peak ratios such as a larger spread in their Cu/Cr and SiOH/Cr ratios. They also had excessive levels of hydrocarbons.

Fig 3. Example comparison of SIMS spectra for the 2 extreme component samples. The silver tube appears to be organic and silicon contaminated.

This scrapping decision prevented both yield loss in downstream processes and risking customer returns with all the associated bad publicity. Through further discussion the root cause was determined to be at the supplier. They had mistakenly delivered material intermixed with small volumes of a different metal alloy. A supplier audit process prevented this reoccurring through the resultant improvements in their production traceability.
