Industrial Problem Solving and Failure Investigation of Modern Materials

Dr Simon Romani – Technical Director

Aerospace / Advanced Engineering Show 2016 (NEC) - 2nd November 2016

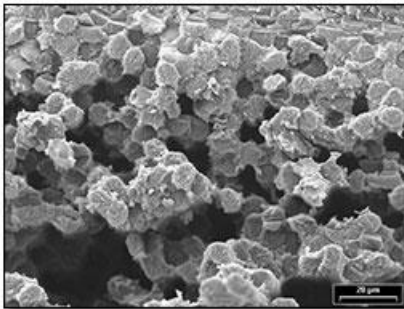
CFRP Fracture Surface

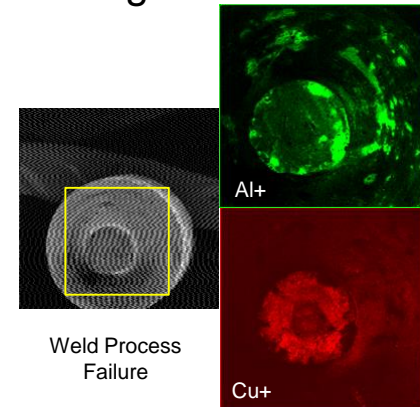
Weld Process Failure

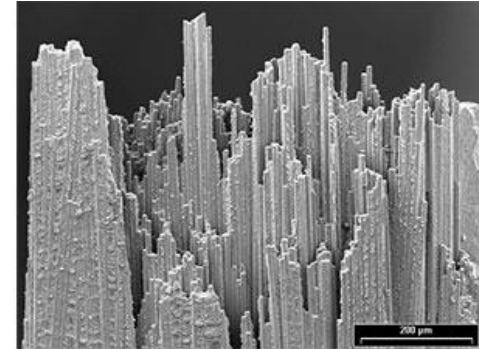
Figure 1 - Carbon Fibre Fracture Surface

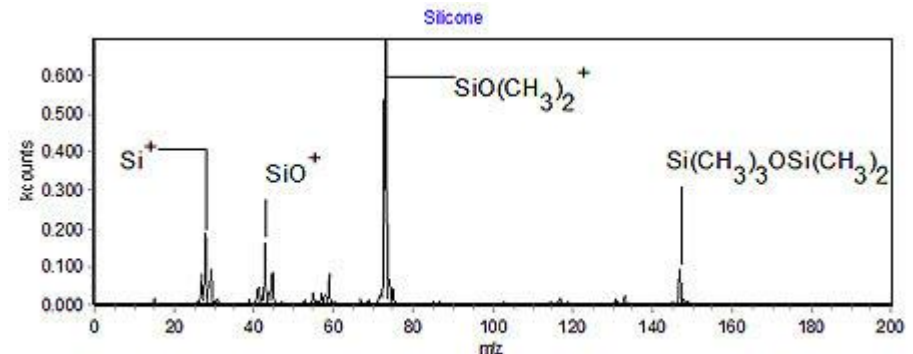
e.g. SIMS can show plasticisers segregating to surface (shown here..), or residual mould release agents, etc..

Figure 2 - SIMS Spectrum of Typical Silicone Plasticiser on a Plastic Surface

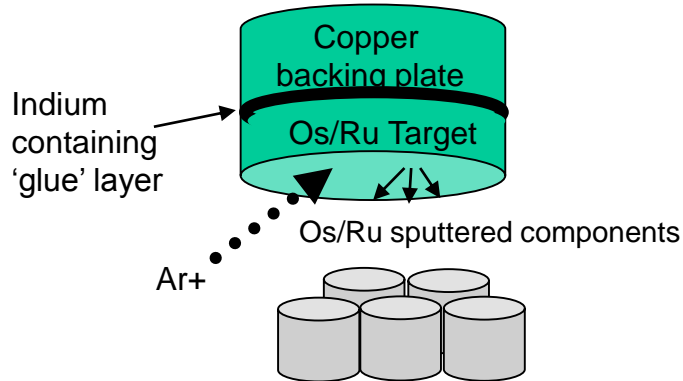
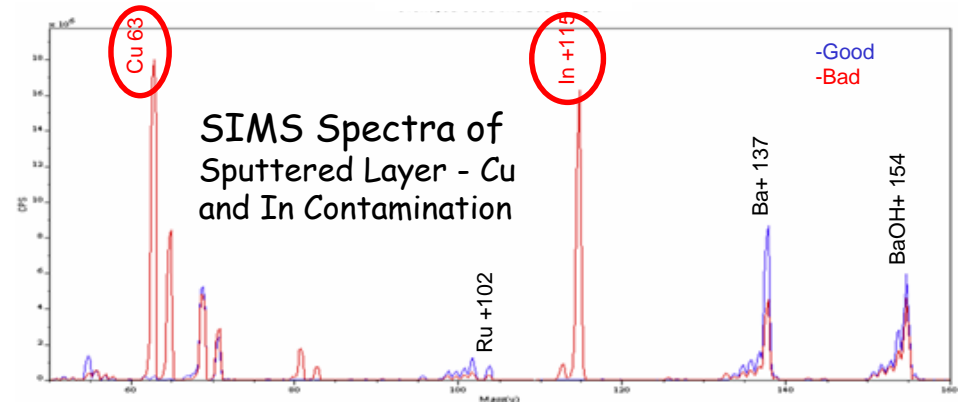
Sputtering Target End of Life

Cathode emission performance tests & production data showed a manufacturing Quality change....

Cu or In on Pellet surface reduced cathode emission.

Undetected software glitch had reset the target counter life so target worn through to backing plate.

SIMS sensitivity and sample rapid throughput allowed quarantine of finished & unfinished batches across production time frame and to release rest of production.

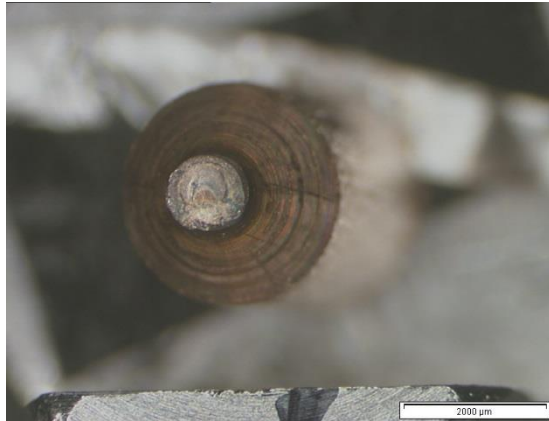
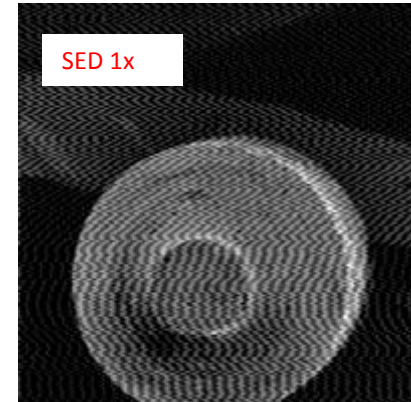
Additional Example1: Spot Welding Process Stability Investigations

Spot welding - weld strength varying per weld shot.

- Weld pull strength drift vs time.
- Power / Force / Spot and HAZ size unstable over electrode life.
- DoE process trials could not optimise process.

- Electrode edges rounding.
- Copper Alloy with Alumina particles for hard wearing property throughout.

- Build up of thin layers of alumina at edge.
- Quantity of residual alumina changed electrode resistance so power per unit area and force varied over time.
- Weld power set too low to stop alumina build up.

Higher Power and Force Solved Problem.

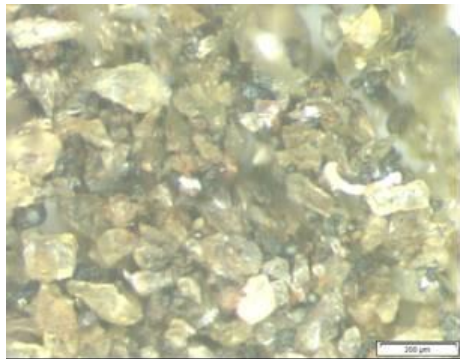
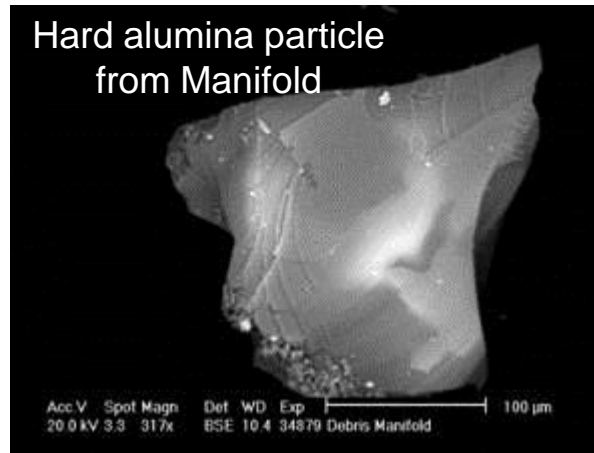
Additional Example2: Deposits Wearing a Water Pump Interior - Early life failure

- Characterise the deposits from inside the pump, likely cause and implications for pump.
- Particle sizes and shapes are characteristic of source (optical microscopy and SEM/EDX)
- Source of hard particles critical to cause – Degradation or External contamination?

Packing material – Polyurethane prepolymer - Not fully cured
- Not a source of inorganic debris

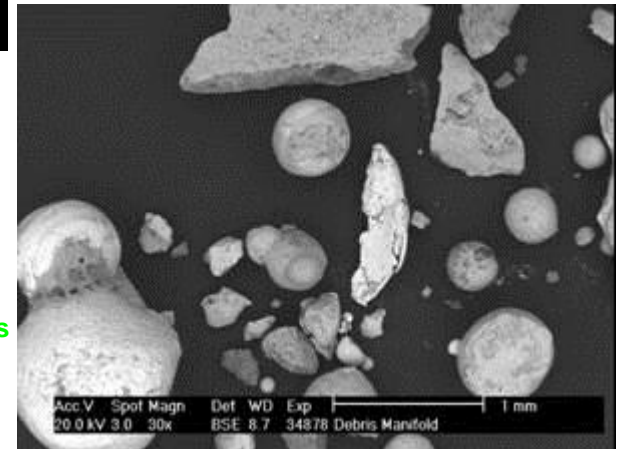
Irregular titanium rich probably metallic flakes

Iron Oxide Coated Spheroidal Particles – Weld Splatter

Common Aluminosilicate Glass Particles / Fragments
