Consultant Metallurgical Investigation of a Failed Wood Drill Bit

Report Number: T1234

23 April 2020

LPD Lab Services Limited

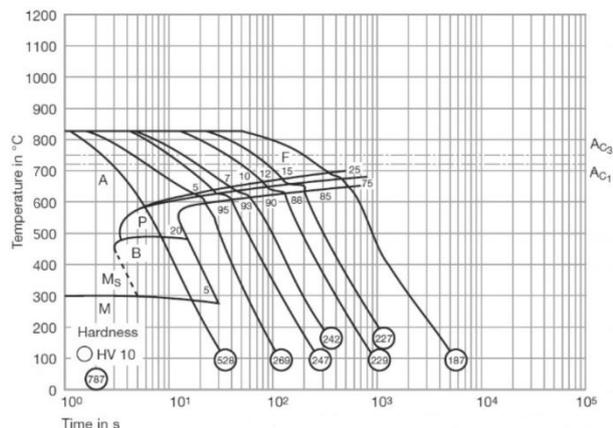
Figure 10. Continuous cooling transformation (CCT) diagram for AISI 1060 steel.

This undesirable microstructure would have been the results of an improper heat treatment. It is likely that the material was not fully austenitised before quenching, but it could also be that the quench rate was slower than the critical rate required to fully transform to martensite. The latter could occur if the drill bits were packed tightly into relatively large bundles to help maintain straightness during heat treatment. Steels with no alloy addition have limited hardenability and cannot transform fully to martensite if the ruling section is not sufficiently small (a larger mass cools significantly slower than a smaller mass and the slower it cools the less likely it is to transform to martensite).

The composition of the drill bit material (with lower carbon) was similar to that of AISI 1060 steel. This material would be expected to obtain a hardness in the order of 300 to 400 HV10 if suitably quenched and tempered, depending on the size of the component and the tempering temperature (smaller diameter and lower temper temperatures would be expected to attain higher hardness values and vice versa). Figure 10 shows a continuous cooling transformation (CCT) diagram for AISI 1060 steel with the as quenched hardness indicated at the end of each indicated cooling rate (subsequent tempering will lower the final hardness). It is observed that this type of material can obtain the desired microstructure and mechanical properties if quenched fast enough. If in manufacture the drills are grouped tightly together during heat treatment, to maintain straightness, then it is advisable to use an alloyed steel that possesses the desired hardenability.
